# Inspection Report

**Property Address:**  
123 Any Street  
OKC OK 73099

**Gutter2Gully Home Inspections LLC**

20220323-Sample

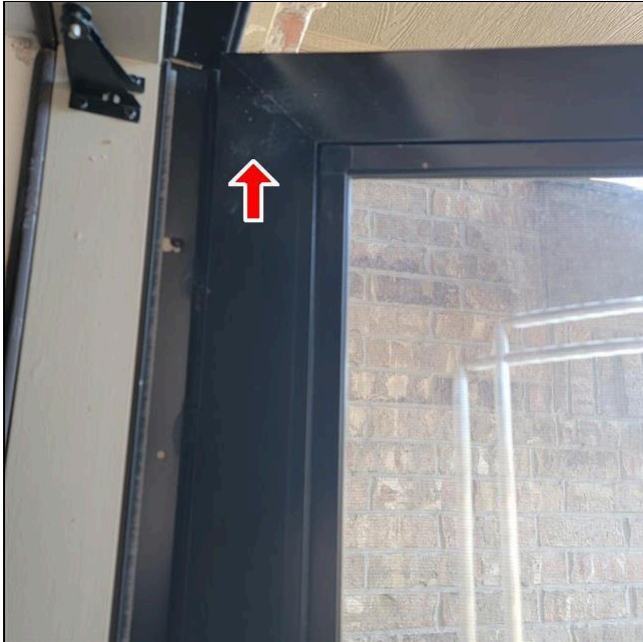
2.1 Item 1 (Picture) Front Storm Door

(1) Hydraulic closer is missing on front entry storm door.

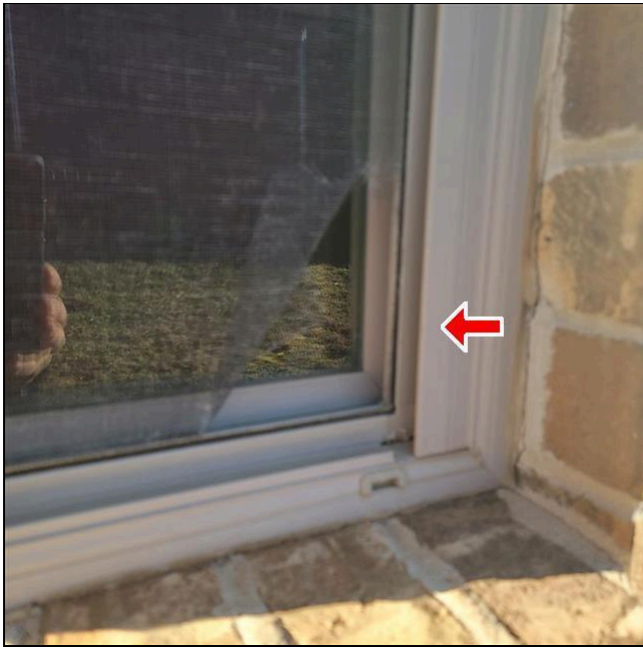
2.2 Item 1 (Picture)

(1) Damage to window screen south side.

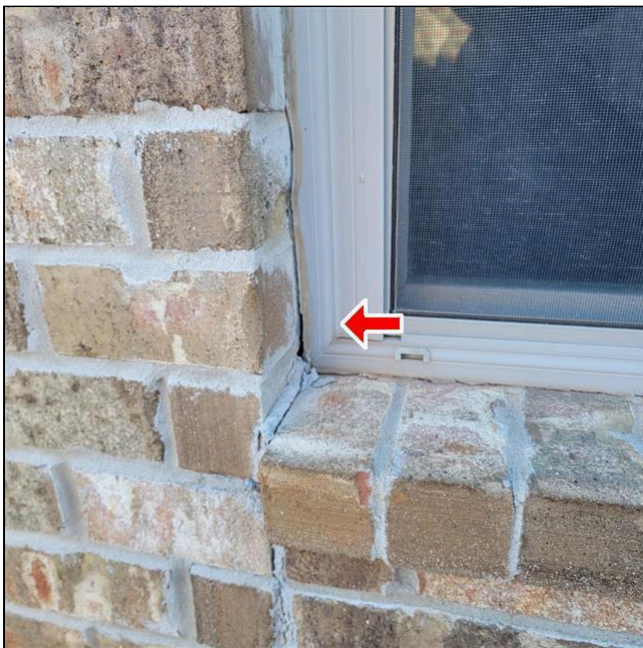
2.2 Item 2 (Picture)

(2) Caulking on several windows is cracked and separating. Recommend re-caulking to seal window properly.

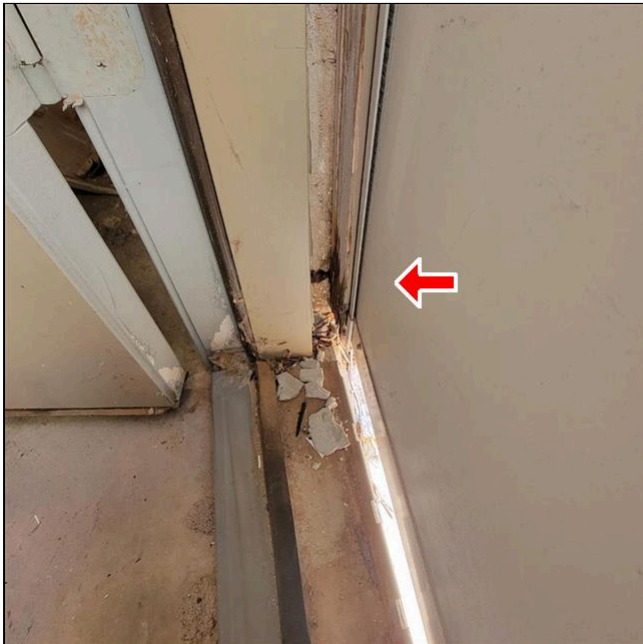
3.3 Item 1 (Picture)

The storm door on the single entry door at the back of the garage has broken loose and shows damage to the wall section. Recommend this be repaired or replaced by qualified installer.

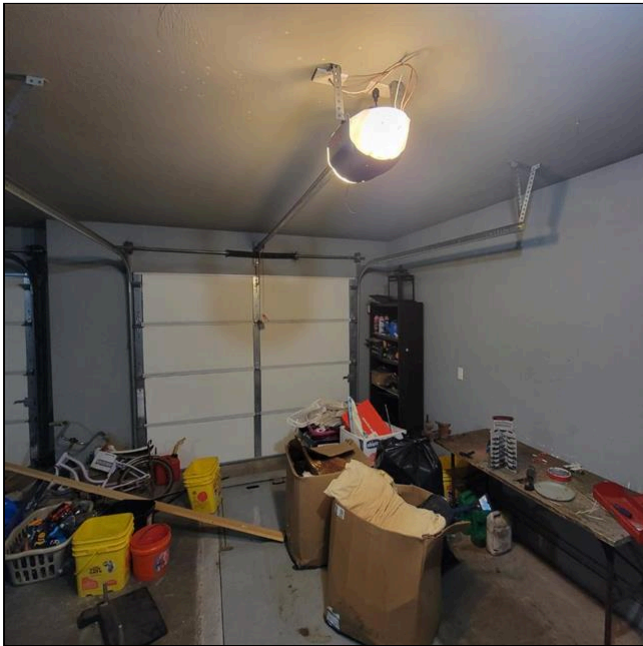
3.6 Item 1 (Picture)

(1) The automatic opener at the (left door when facing garage from outside) does not operate properly. A repair or replacement is needed. I recommend a qualified garage door repairman correct as needed.

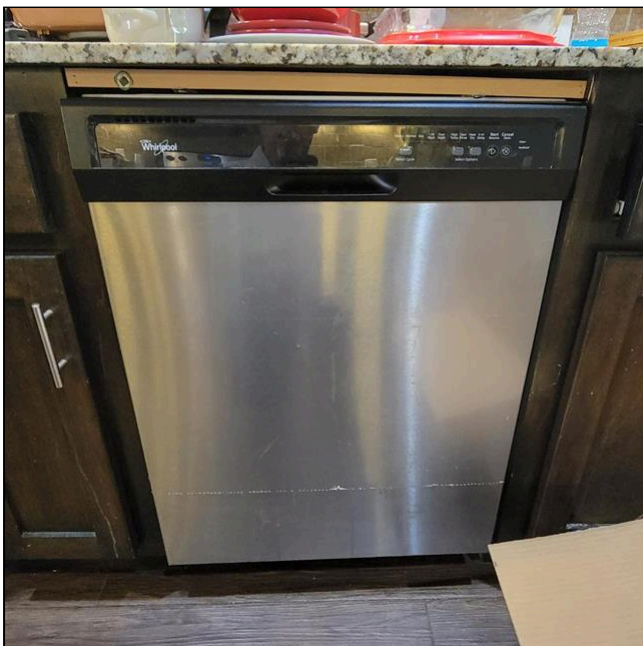
4.4 Item 1 (Picture)

Dishwasher was present but not tested. Personal items are not moved during inspections. Recommend testing after items are removed.

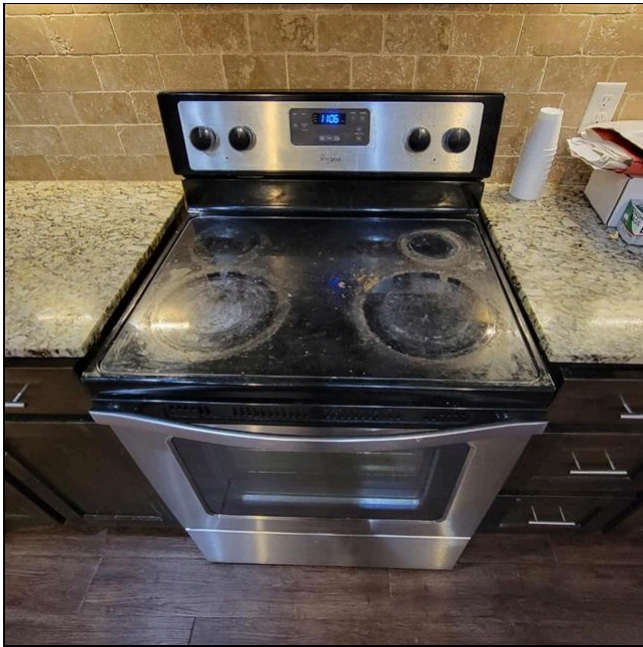
4.5 Item 1 (Picture)

No anti-tip bracket was installed on oven/range. Recommend installation of Anti-tip valve for safety.

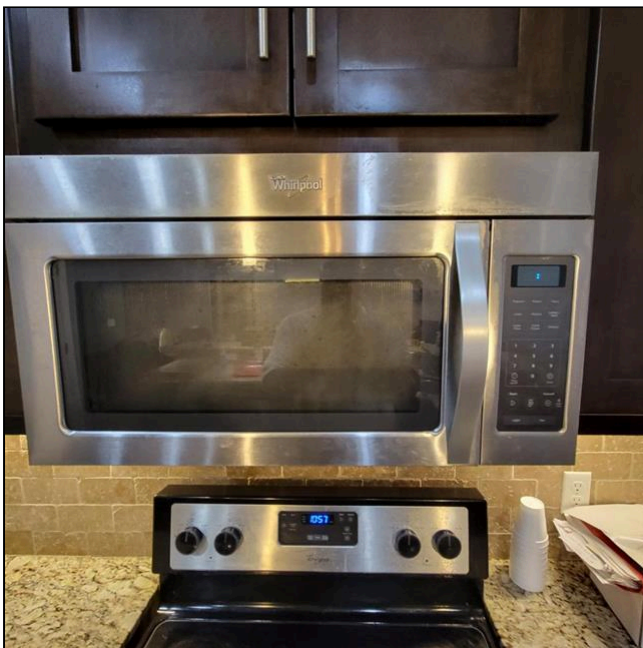
4.8 Item 1 (Picture)

The microwave needs cleaning or is stained in areas. I recommend repair as needed.

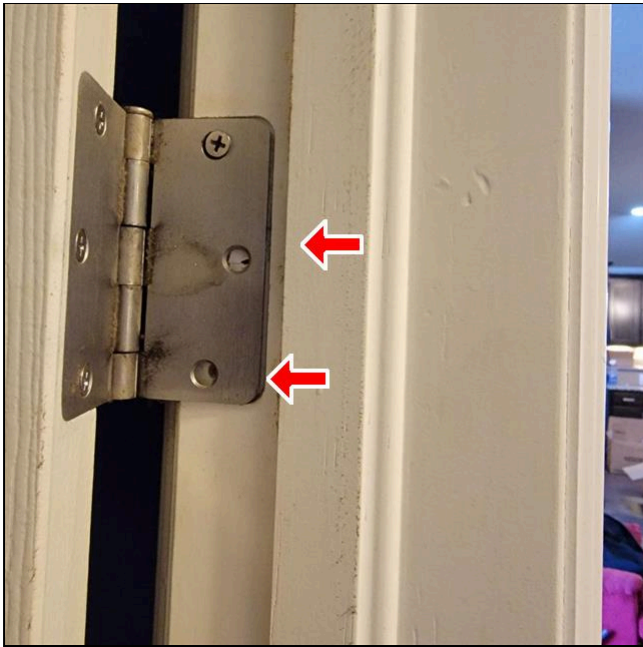
5.4 Item 2 (Picture)

(2) The top hinge is missing screws at bedroom number 1 door. I recommend repair or replace by a qualified person.

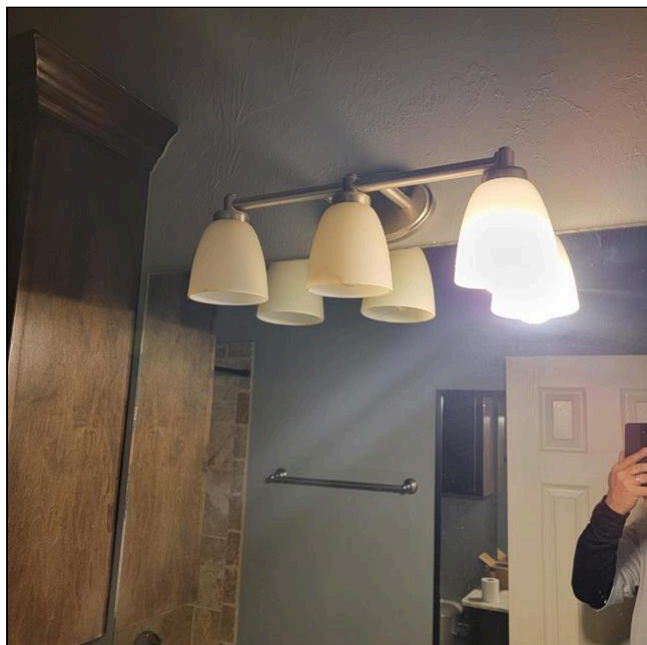
6.8 Item 1 (Picture)

The light fixture does not work properly (try bulb first). This is for your information. I recommend repair as needed.

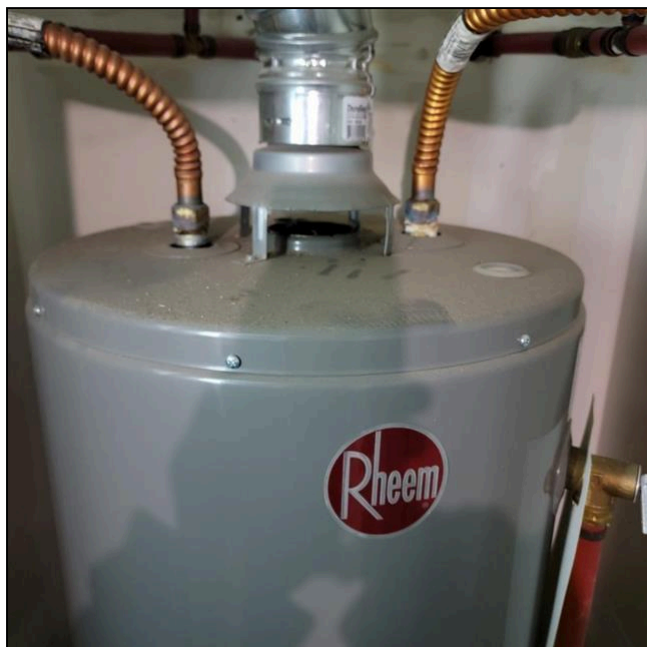
8.2 Item 1 (Picture)

Hot Water Tank located in garage.

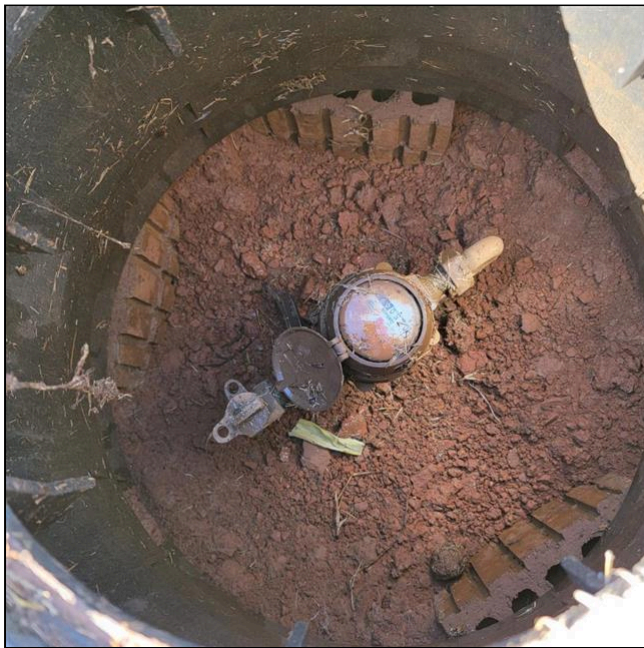
8.3 Item 1 (Picture)

The main shut off is located outside in the ground.

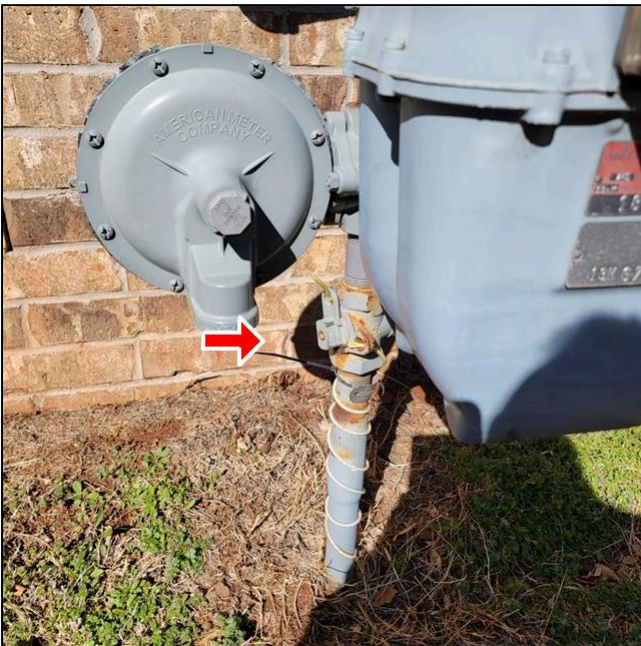
8.5 Item 1 (Picture)

The main fuel shut off is at gas meter outside

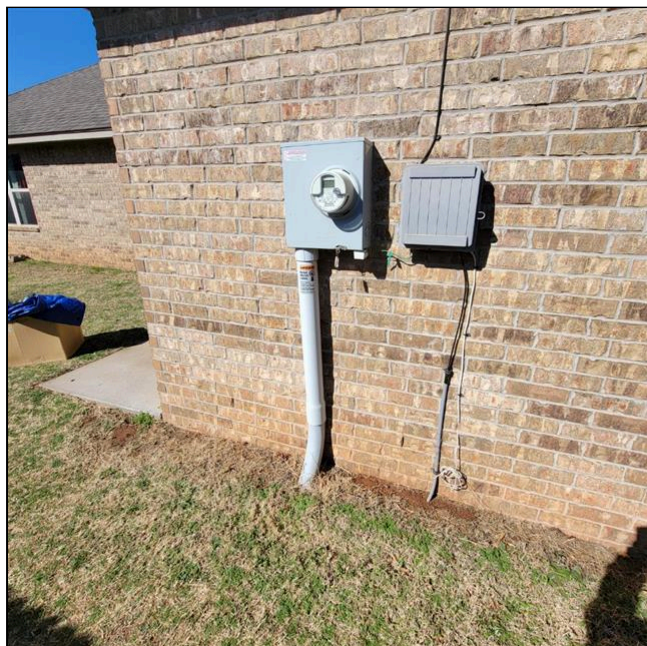
9.0 Item 1 (Picture) Electrical Meter

Meter located on East side of house.

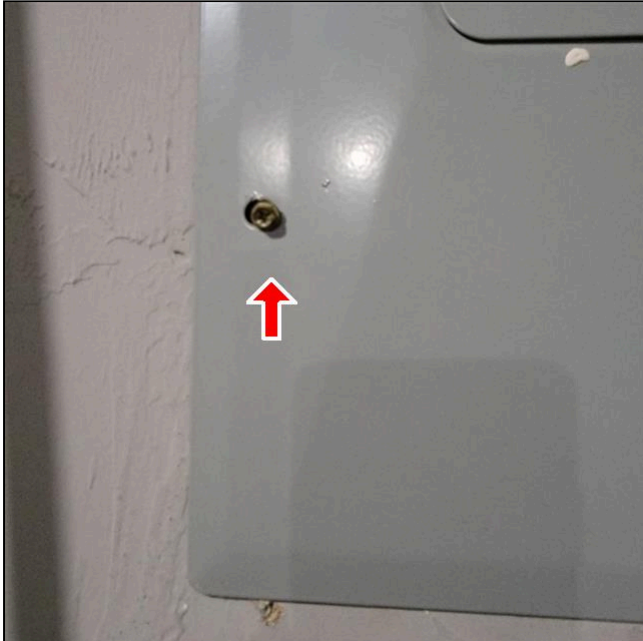
9.7 Item 1 (Picture)

(1) Wrong mounting screws on dead front

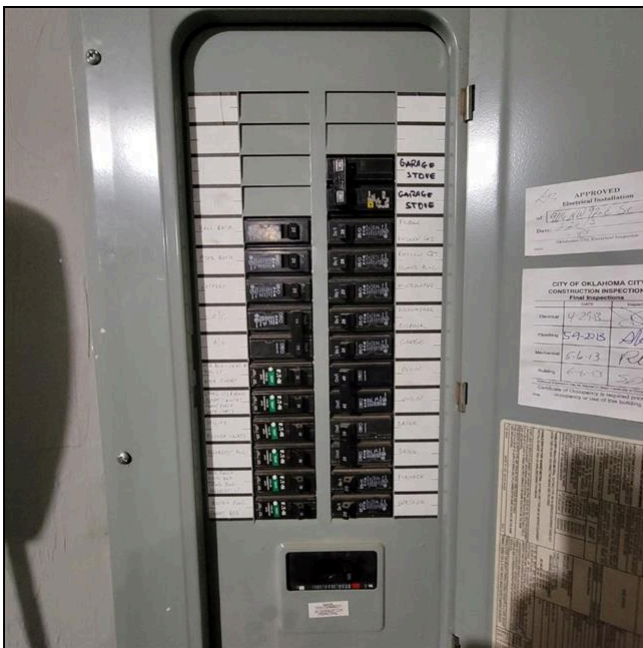
9.7 Item 2 (Picture)

(2) The main panel box is located at the garage.

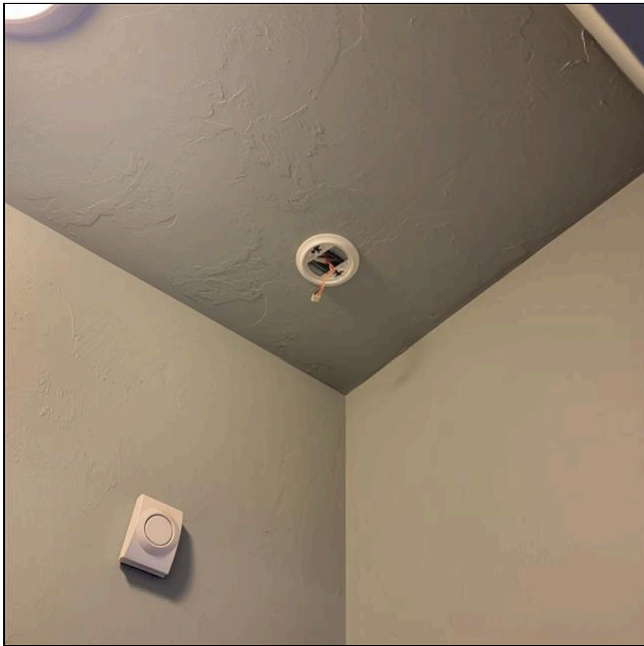
9.8 Item 1 (Picture)

The smoke detectors have been disconnected intentionally at the common hallway to bedrooms and in bedrooms. Without a working smoke detector in your home you have no first alert to a possible fire. A qualified person should repair or replace as needed.

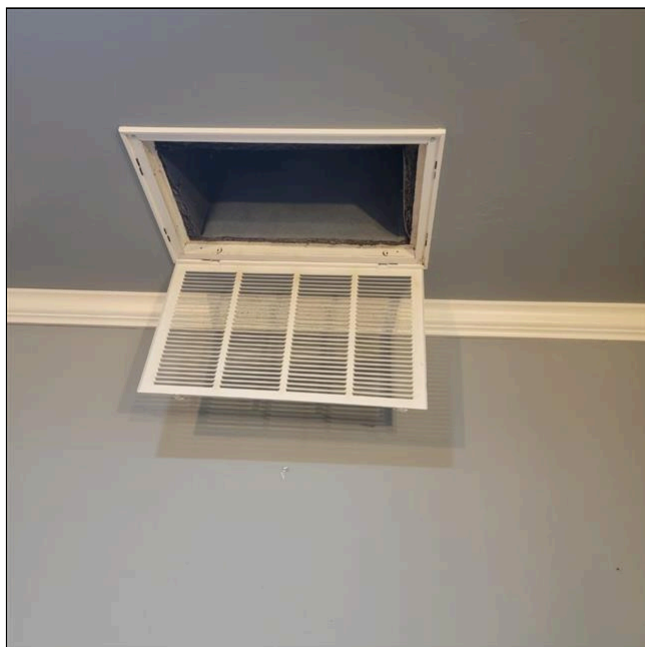
10.3 Item 1 (Picture)

Air filters were removed from return vents.

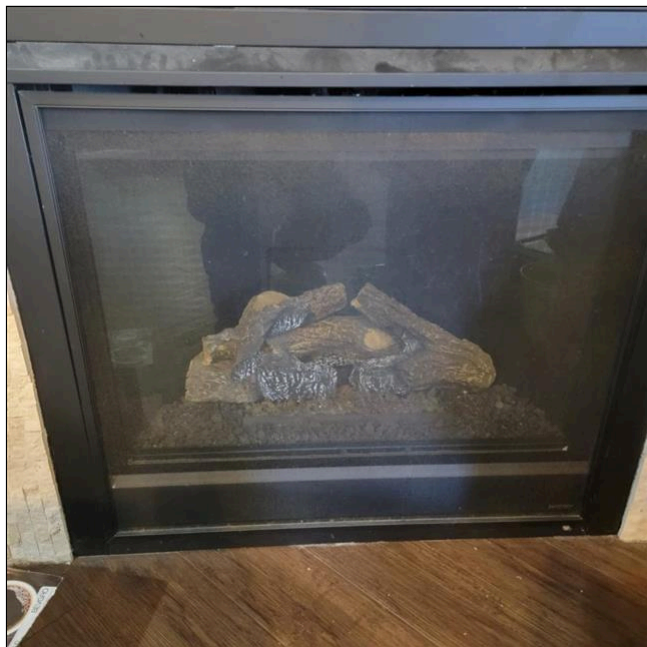
10.7 Item 1 (Picture)

Could not get fireplace to operate. Recommend evaluation and/or repair by licensed installer.

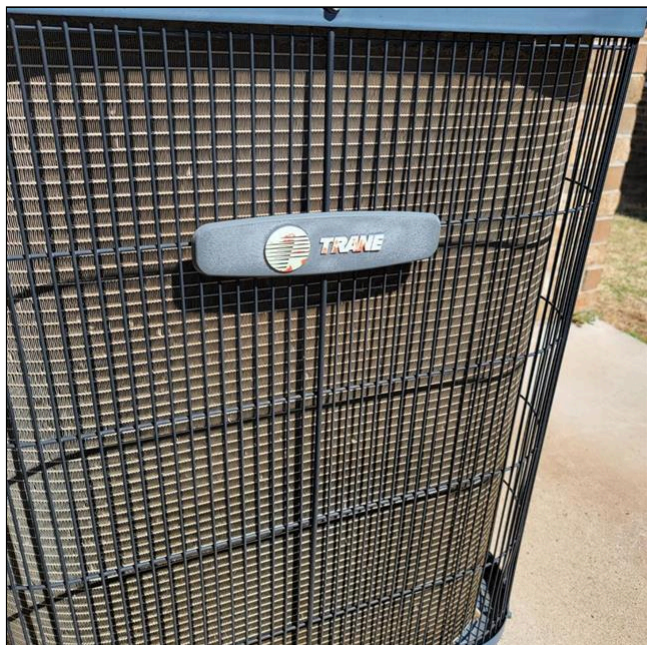
10.8 Item 1 (Picture)

A/C was not tested at time of inspection as outside temperature was too low to safely operate the A/C. Outside temperature needs to be above 68 degrees so the compressor is not damaged. Recommend testing A/C when temperature allows.

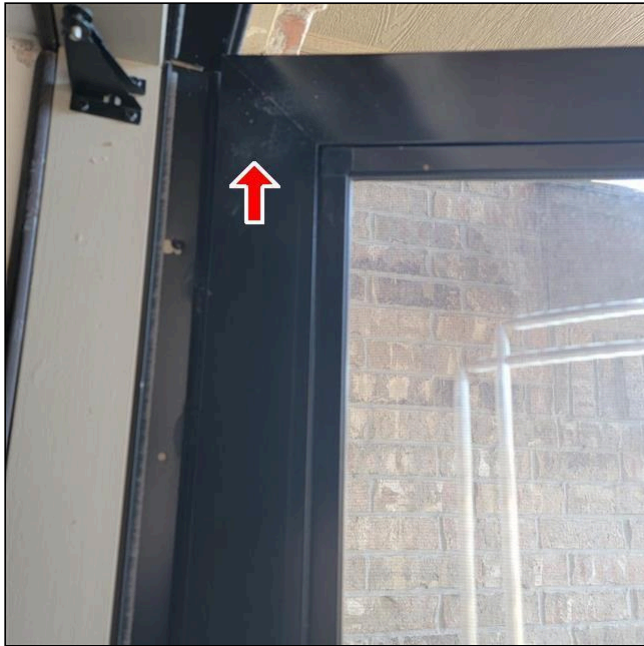
2.1 Item 1 (Picture) Front Storm Door

(1) Hydraulic closer is missing on front entry storm door.

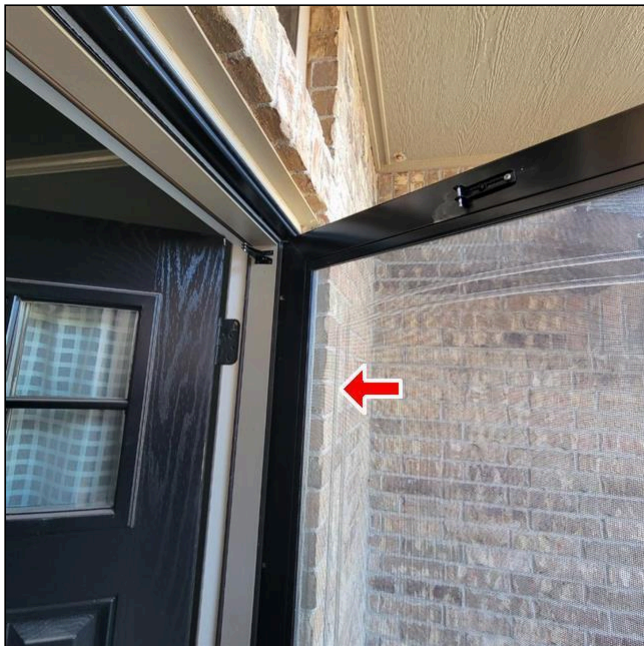
2.1 Item 2 (Picture) Front Storm Door

(2) Front entry storm door is missing a retaining clip allowing the window and screen to be loose. Replace clip to tighten window and screen.

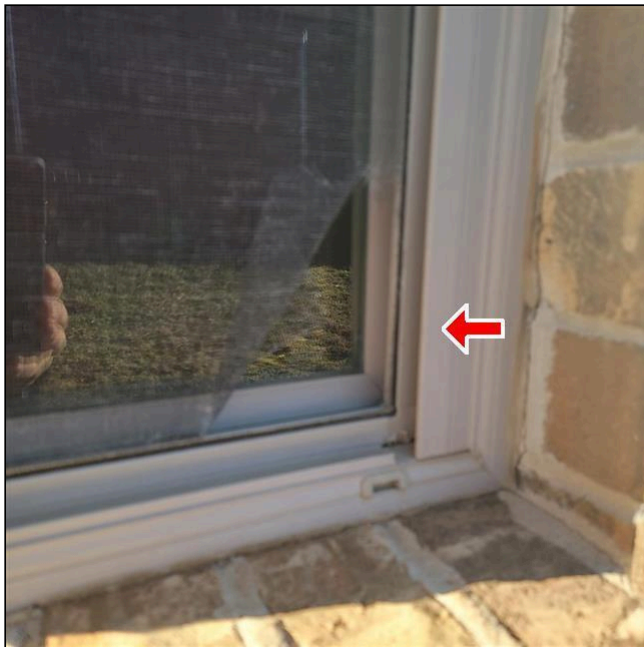
2.2 Item 1 (Picture)

(1) Damage to window screen south side.

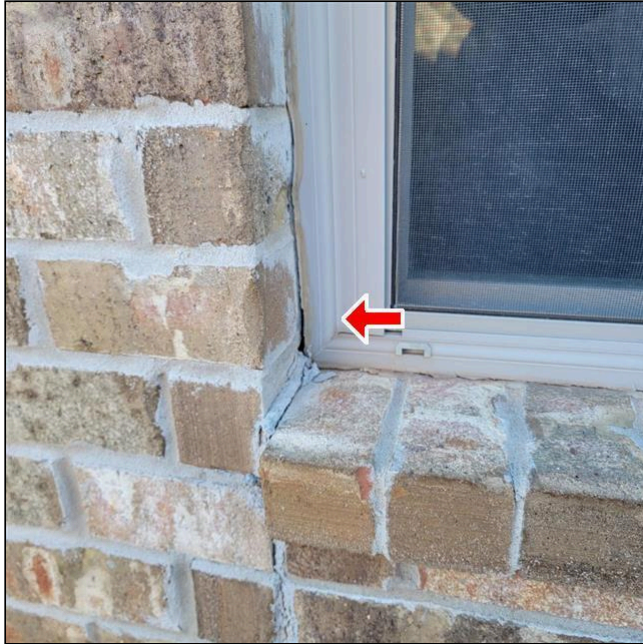
2.2 Item 2 (Picture)

(2) Caulking on several windows is cracked and separating. Recommend re-caulking to seal window properly.

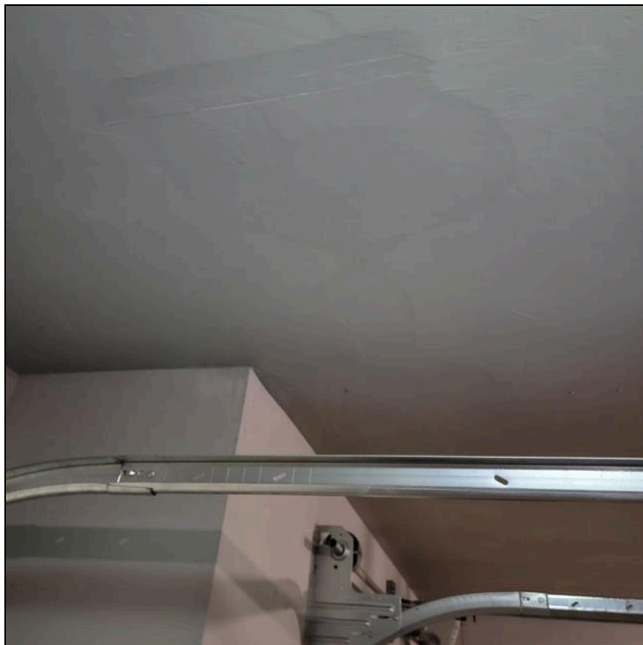
3.0 Item 1 (Picture)

The Sheetrock on the garage ceiling reveals a light stain which appears from a water leak. Stain appears old. The moisture meter was used and it did not indicate an active leak. I recommend monitor and repair or replace if the leak repair was not successful.

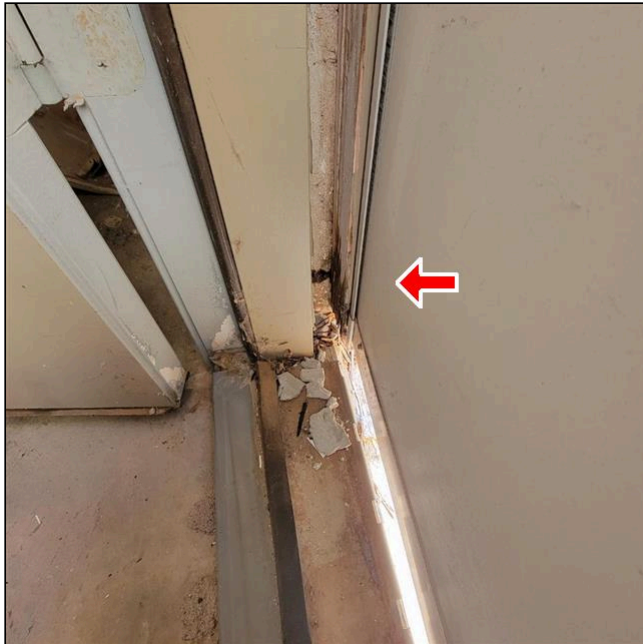
3.3 Item 1 (Picture)

The storm door on the single entry door at the back of the garage has broken loose and shows damage to the wall section. Recommend this be repaired or replaced by qualified installer.

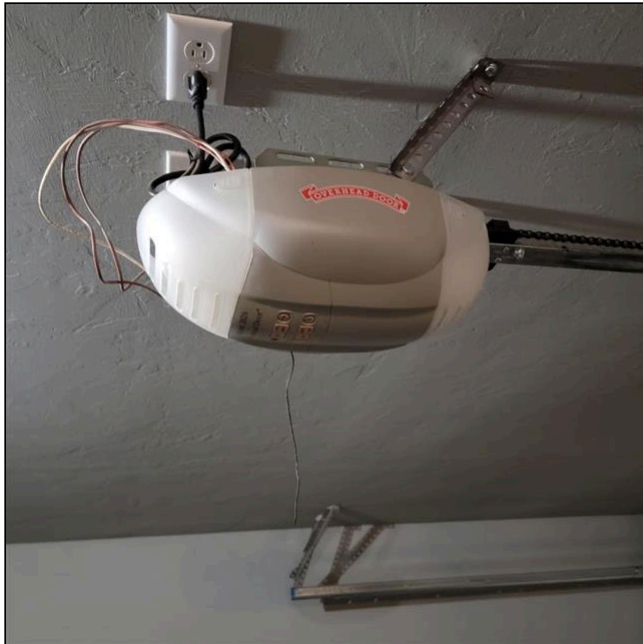
3.6 Item 2 (Picture)

(2) The automatic opener at the (right door when facing garage from outside) has a missing or burned out light bulb. This is a maintenance issue and is for your information. I recommend a qualified garage door repairman correct as needed.

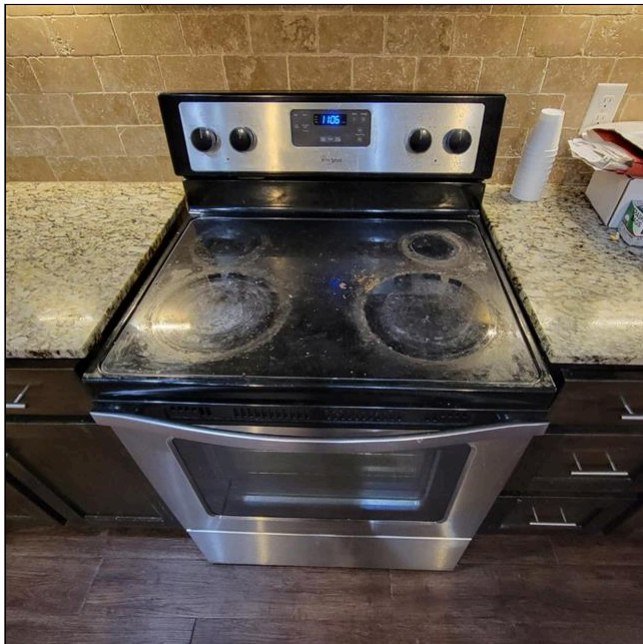
4.5 Item 1 (Picture)

No anti-tip bracket was installed on oven/range. Recommend installation of Anti-tip valve for safety.

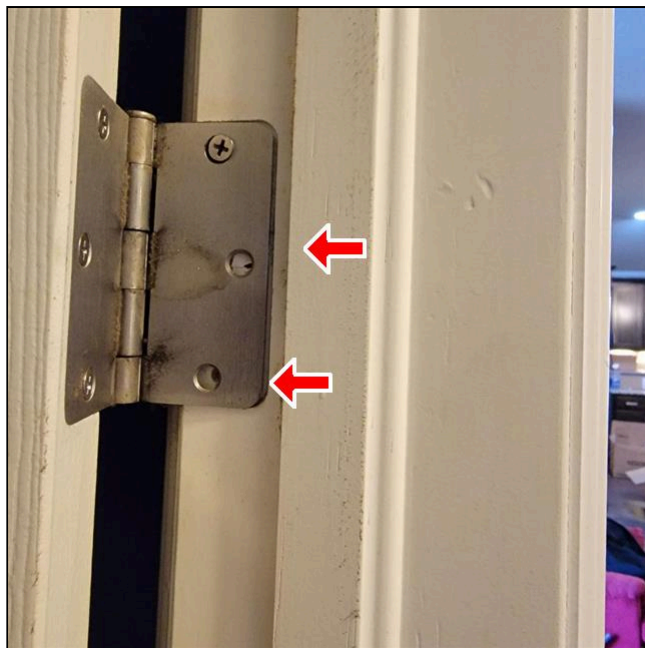
5.4 Item 2 (Picture)

(2) The top hinge is missing screws at bedroom number 1 door. I recommend repair or replace by a qualified person.

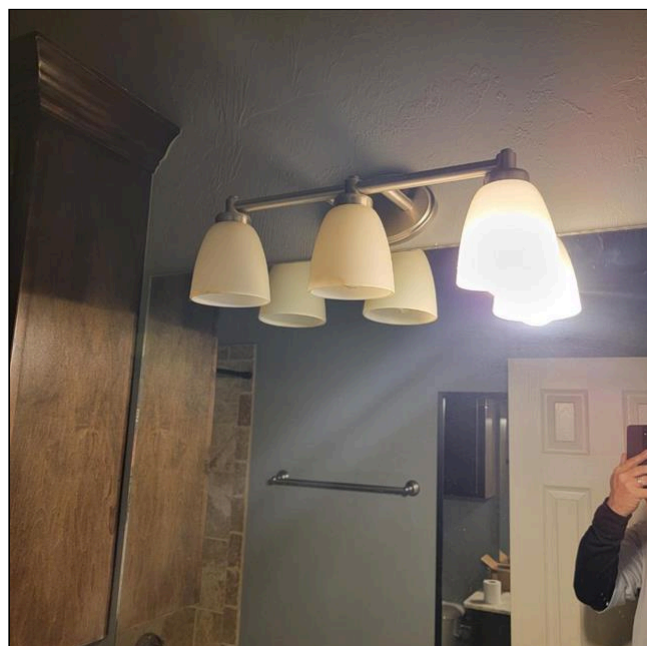
6.8 Item 1 (Picture)

The light fixture does not work properly (try bulb first). This is for your information. I recommend repair as needed.

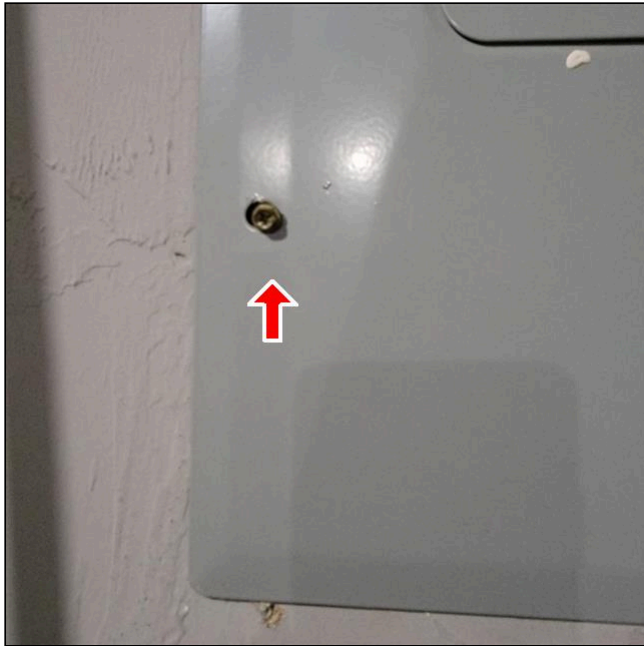
9.7 Item 1 (Picture)

(1) Wrong mounting screws on dead front

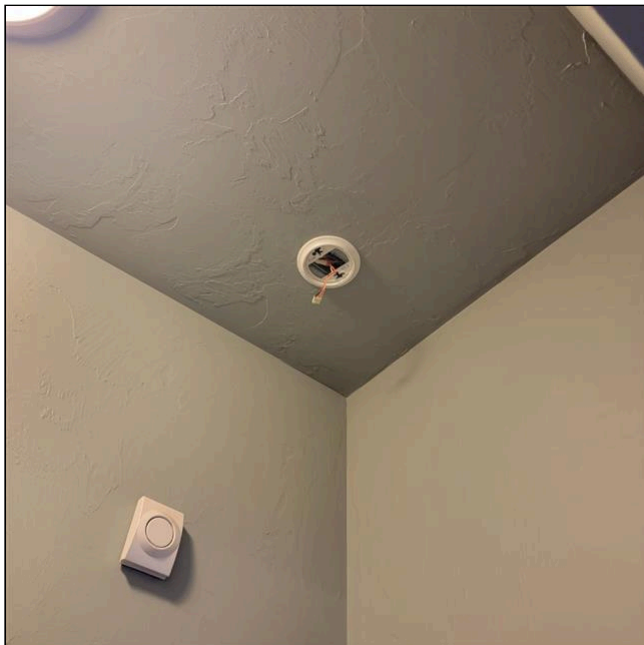
9.8 Item 1 (Picture)

The smoke detectors have been disconnected intentionally at the common hallway to bedrooms and in bedrooms. Without a working smoke detector in your home you have no first alert to a possible fire. A qualified person should repair or replace as needed.

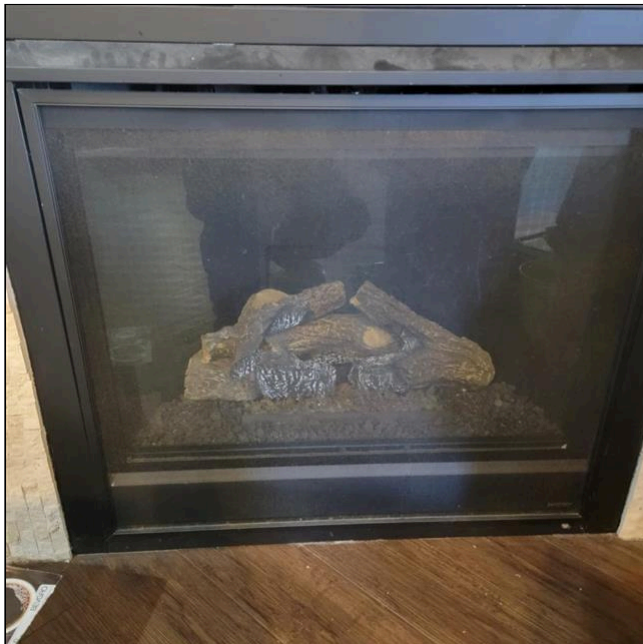
10.7 Item 1 (Picture)

Could not get fireplace to operate. Recommend evaluation and/or repair by licensed installer.
